**FULTON COUNTY COURTHOUSE
DESIGN/BUILD RESTORATION:**

**MULTI-AWARD WINNING
HISTORIC RESTORATION
IN GEORGIA**

BY BRETT LAUREYS, WISS JANNEY ELSTNER, ASSOCIATES, INC.
AND JOHN KROUSE, BOSTON VALLEY TERRA COTTA

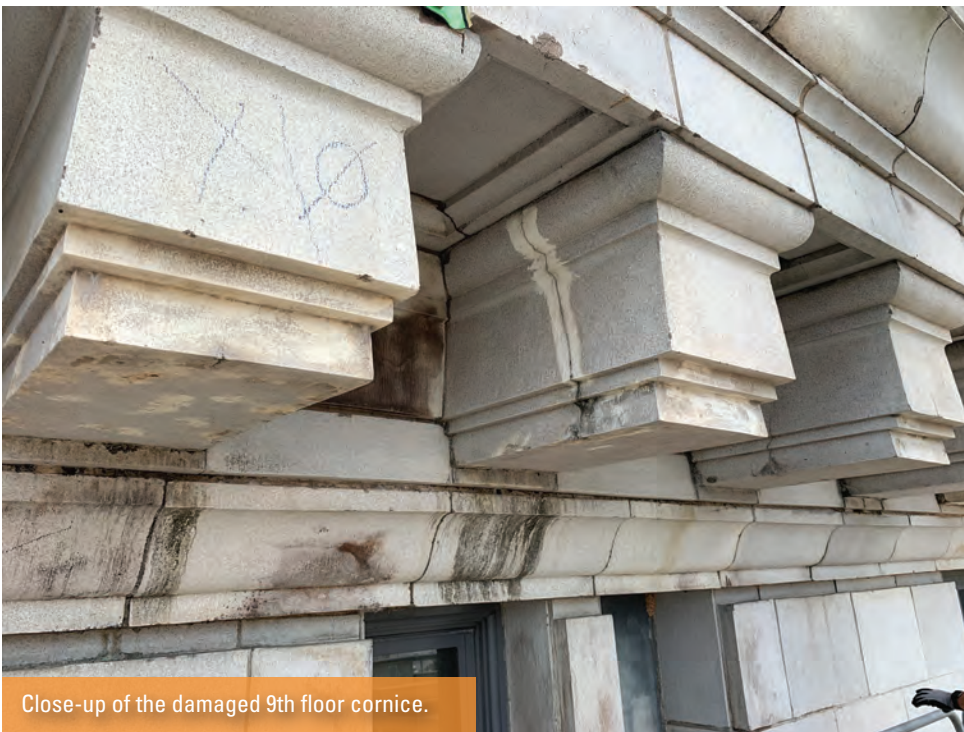
In 2016, Fulton County commissioned an engineering firm to review the overall condition of the exterior façade of the courthouse after cracked and displaced terra cotta façade elements were observed at the 9th floor cornice. The findings of this initial study revealed that there were several hazardous conditions on the exterior façade of the building that were in danger of falling and, in 2017, Fulton County installed emergency overhead protection above the sidewalks and entrances to protect the public. Based on the extent of deterioration, cost of access to fully evaluate the exterior of the building, and

Close-up of the damaged 9th floor cornice.

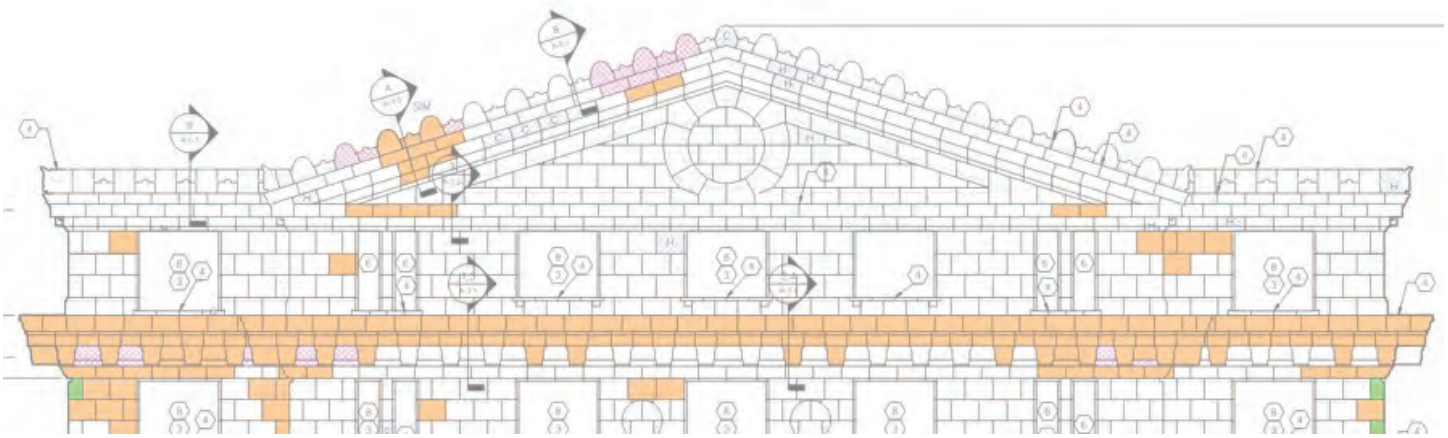
WJE identified the terra cotta units that required repair or replacement during the initial close-up assessment and logged them electronically in PlanGrid®.

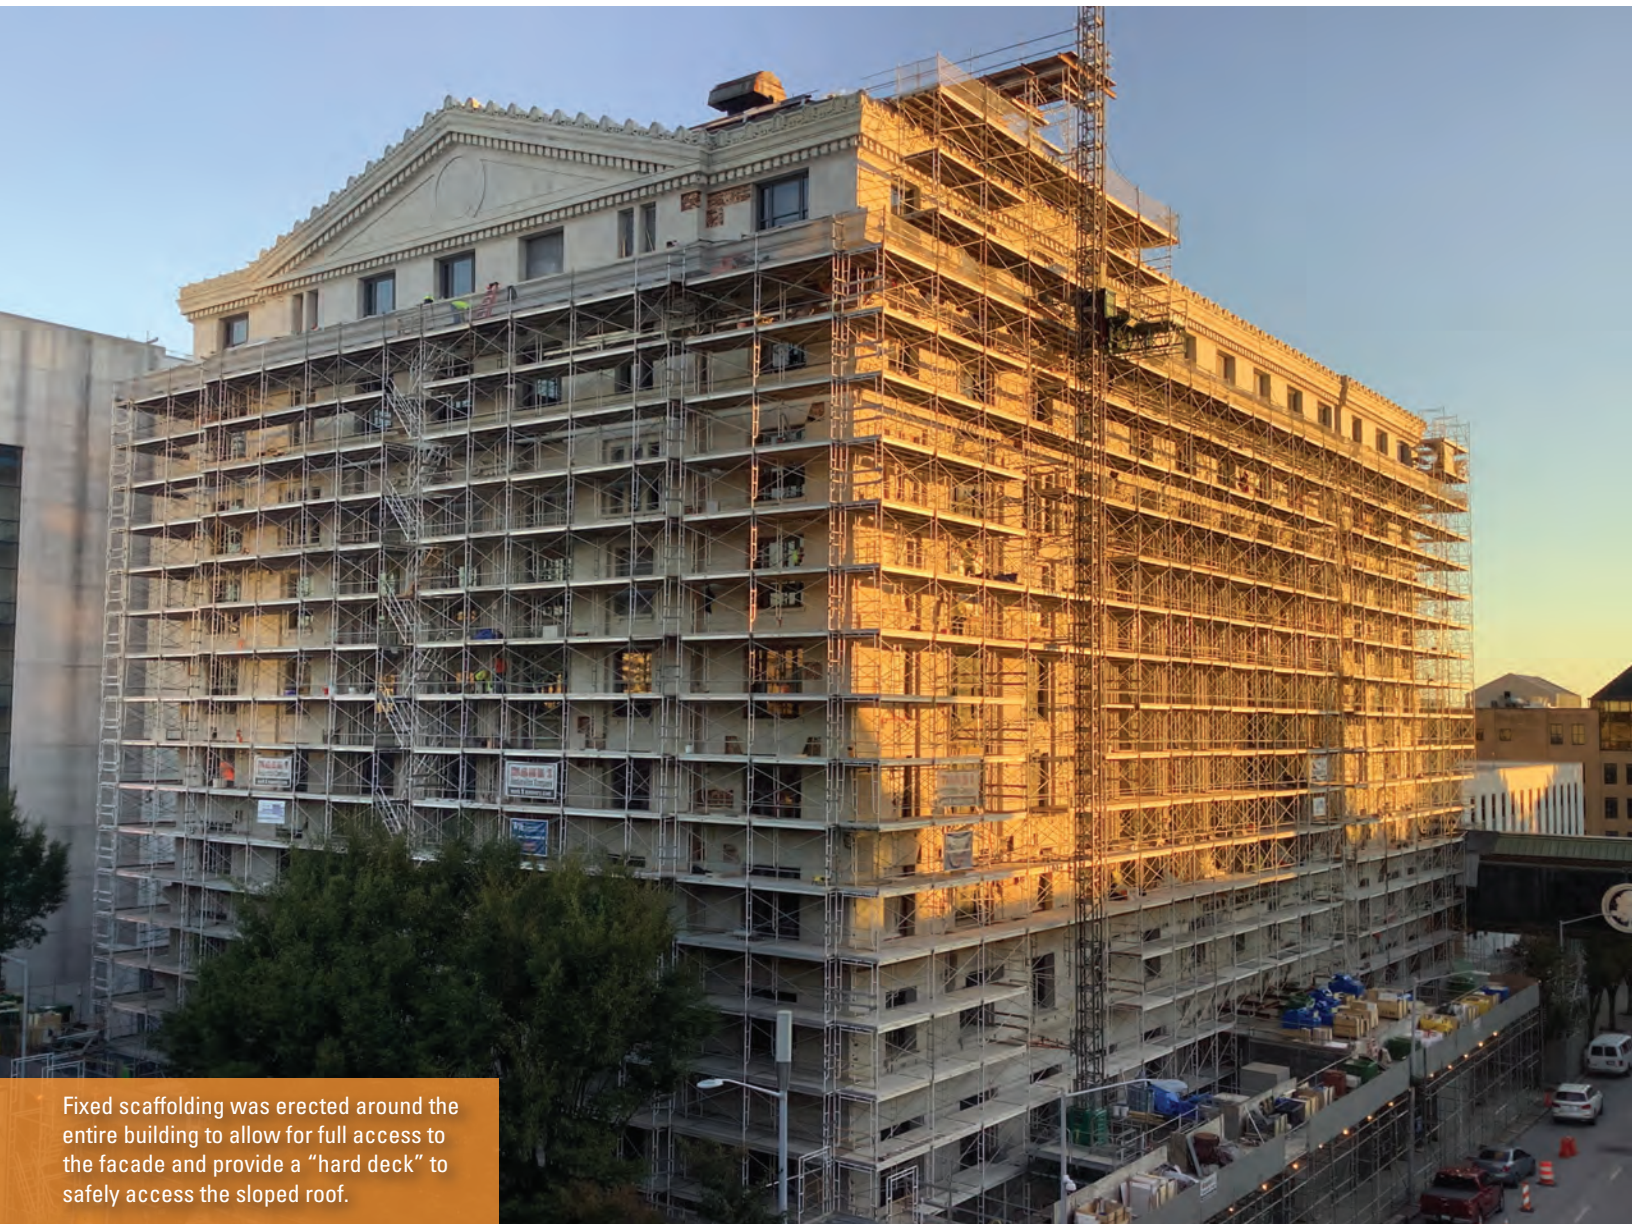
Fixed scaffolding was erected around the entire building to allow for full access to the façade and provide a “hard deck” to safely access the sloped roof.

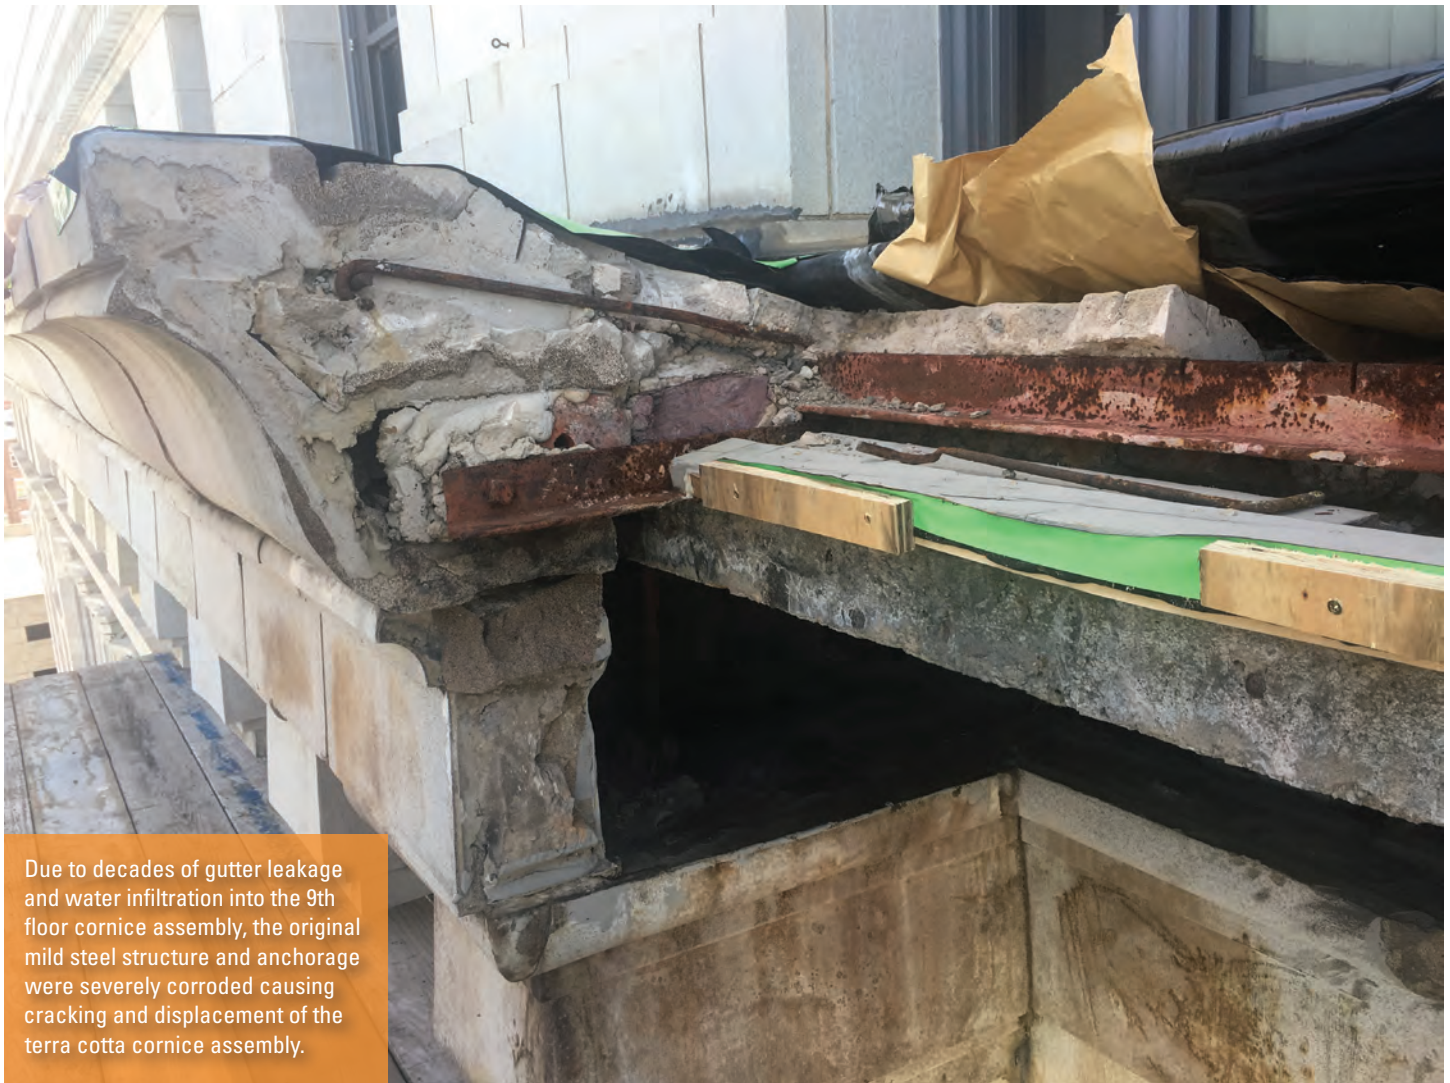
Due to decades of gutter leakage and water infiltration into the 9th floor cornice assembly, the original mild steel structure and anchorage were severely corroded causing cracking and displacement of the terra cotta cornice assembly.

In addition to the general repairs, the most critical component of the building that required repair was the 9th floor cornice. The cornice was over 600 feet long and consisted of three courses of terra cotta set above large, 26 inch wide by 24 inch tall by 40 inch deep, terra cotta bracket units. The cornice was supported from a cantilevered concrete structure and the terra cotta was supported with mild steel double channels, hangers, and lateral anchors. Above and behind the cornice was an original copper sheet metal gutter system. Due to decades of leakage and subsequent water infiltration into the cornice assembly, the original mild steel structure and anchorage in the cornice was severely corroded and was causing severe cracking and displacement of the terra cotta cornice assembly. This unsafe condition required complete removal and replacement of the cornice and repair/replacement of the underlying concrete and steel structural elements.

new cornice assembly. During the initial design, the team developed ideas on how to disassemble the cornice assembly while preserving several of the large bracket units since not all were in need of replacement. The team also developed re-anchorage details that allowed for several of the large bracket units to remain in place during the restoration of the cornice above. During terra cotta design and fabrication, the team modified the original cornice configuration to allow for extrusion of all the typical terra cotta cornice replacement units and to save significant cost.

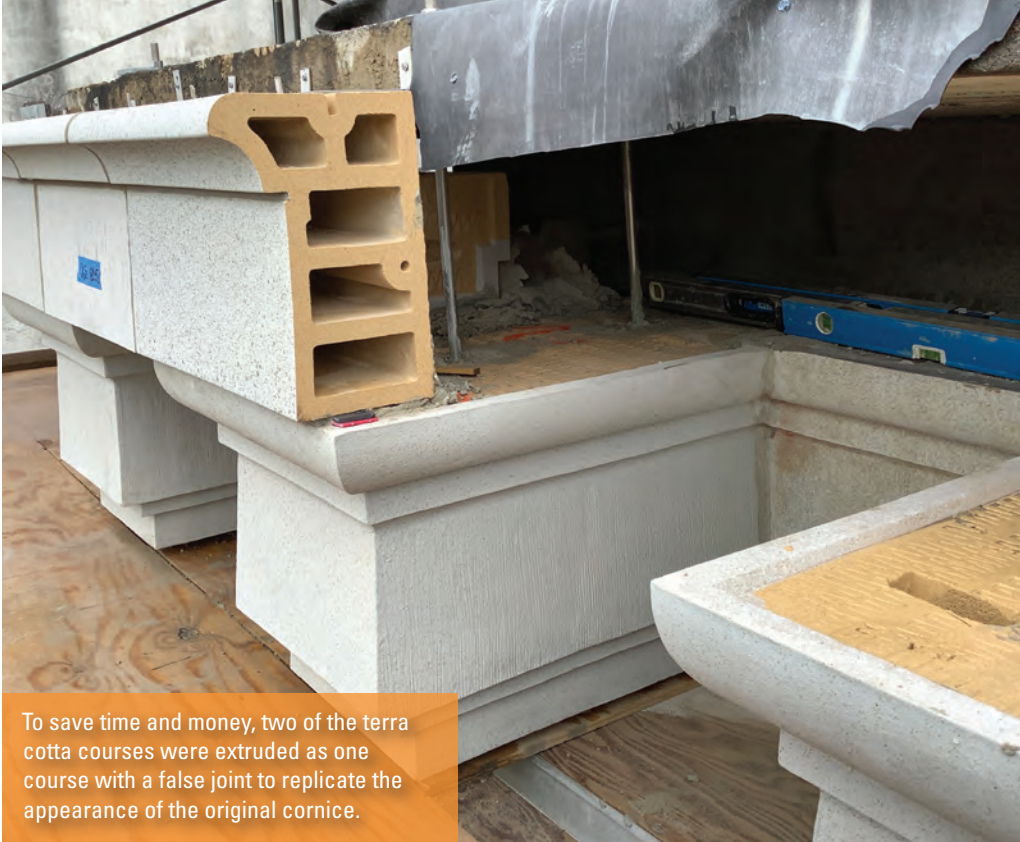
To save time and money, two of the terra cotta courses were extruded as one course with a false joint to replicate the appearance of the original cornice.

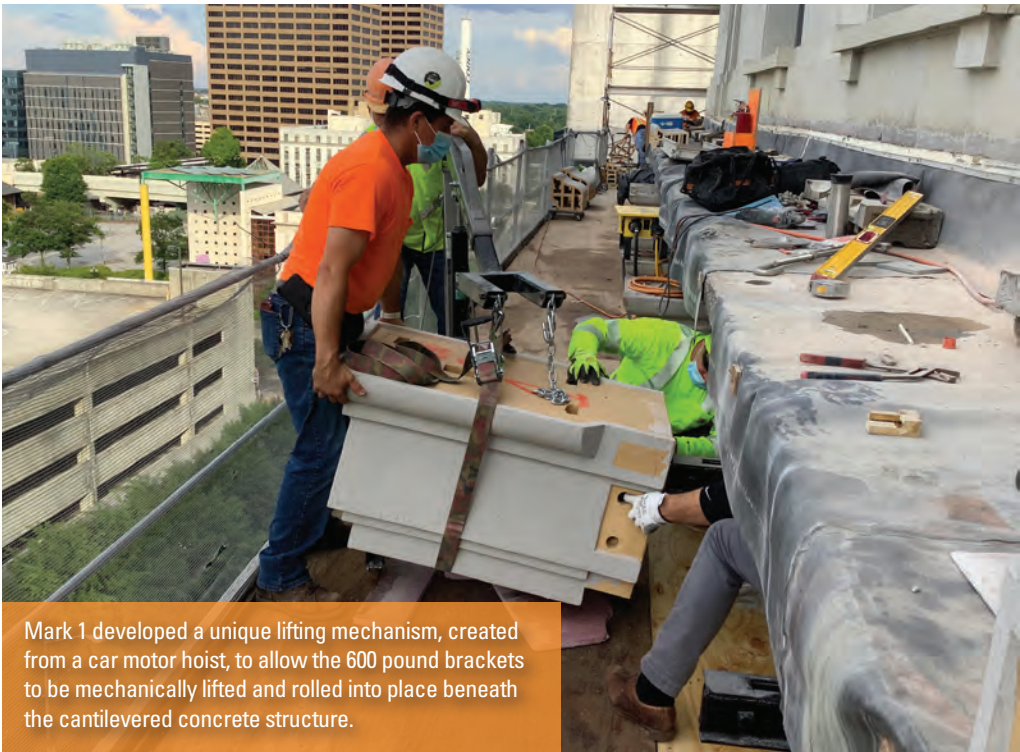
Mark 1 developed a unique lifting mechanism, created from a car motor hoist, to allow the 600 pound brackets to be mechanically lifted and rolled into place beneath the cantilevered concrete structure.

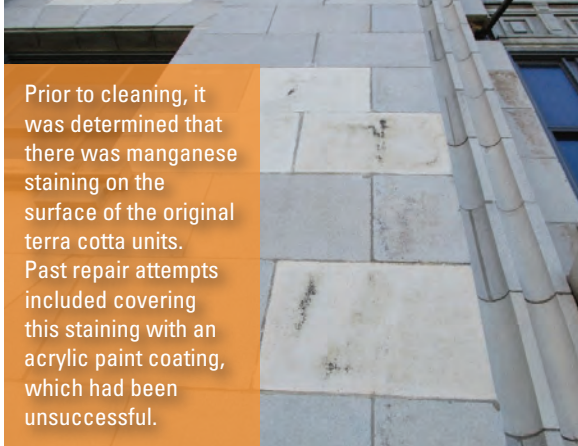
Prior to cleaning, it was determined that there was manganese staining on the surface of the original terra cotta units. Past repair attempts included covering this staining with an acrylic paint coating, which had been unsuccessful.

The other significant project challenge was the staining on the surface of the original terra cotta units. Prior to restoration cleaning, it was determined that there was manganese staining on the surface of the original terra cotta units. This is a brown colored stain that was bleeding through the glaze and the magnitude of the staining varied significantly around the building. From laboratory testing on the original terra cotta units, there was manganese present in the clay body of the terra cotta and also within the terra cotta glaze. Past repair attempts on the building included covering this staining with an acrylic paint coating, which had been unsuccessful.

Between six and nine months after the initial cleaning, small amounts of brown staining began to re-appear during the humid spring and summer months. WJE performed further laboratory studies on cleaned and un-cleaned samples of the original terra cotta due to the re-appearance of the staining. These studies determined that there was a significant amount of manganese in the clay terra cotta units, the glazed surface of the terra cotta was very thin in some locations, and several holes were observed in the glaze. It was determined that the brown staining was re-occurring on the terra cotta units with more significant glaze deterioration and terra cotta units that were highly exposed to moisture/water penetration. Though the wall was pre-wet prior to the initial cleaning, the team determined that some of the oxalic acid within the cleaner likely penetrated the porous surface of the terra cotta units, dried, and then re-mobilized the manganese within the clay body of the terra cotta when moisture was present. The moisture containing manganese then dries on the surface of the terra cotta, causing the brown staining.

In the end, this condition has been occurring over decades of time and is more severe where the terra cotta glaze is most damaged from past aggressive cleaning techniques and locations of high-water exposure (i.e. ledges, below

leaking drains or gutters, etc.). The chemical cleaner used on this project very effectively removes the staining; however, the stain was found to return, though less severe if properly rinsed. The solution for addressing the re-occurring manganese staining was to replace the most severely damaged/stained terra cotta units, re-clean the areas where the more minor staining re-appeared and thoroughly rinse the wall after cleaning, and apply a clear acrylic coating over the surface of the terra cotta units in high exposure areas. The team also developed a protocol for Fulton County to clean/treat areas in the future where the brown staining re-occurs. This was determined to be the most practical and cost-effective solution moving forward.
