**FULTON COUNTY COURTHOUSE
DESIGN/BUILD RESTORATION:**

**MULTI-AWARD WINNING
HISTORIC RESTORATION
IN GEORGIA**

BY BRETT LAUREYS, WISS JANNEY ELSTNER, ASSOCIATES, INC.
AND JOHN KROUSE, BOSTON VALLEY TERRA COTTA

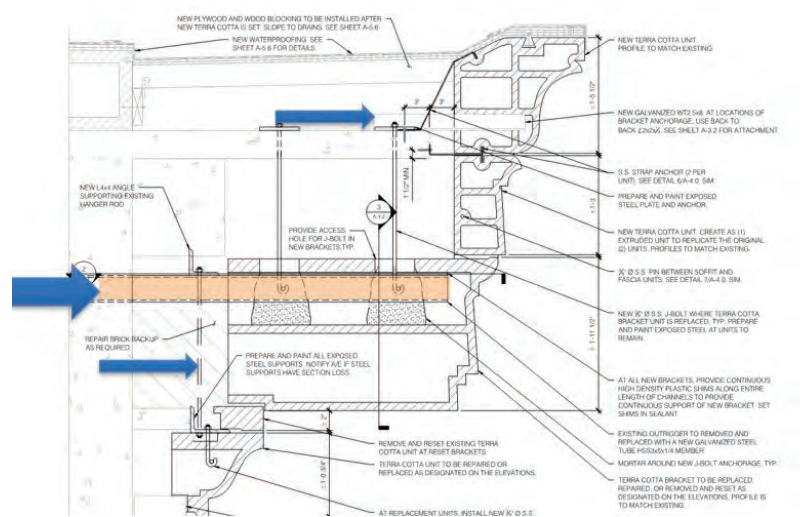
Cornice assembly.

In addition to the general repairs, the most critical component of the building that required repair was the 9th floor cornice. The cornice was over 600 feet long and consisted of three courses of terra cotta set above large, 26 inch wide by 24 inch tall by 40 inch deep, terra cotta bracket units. The cornice was supported from a cantilevered concrete structure and the terra cotta was supported with mild steel double channels, hangers, and lateral anchors. Above and behind the cornice was an original copper sheet metal gutter system. Due to decades of leakage and subsequent water infiltration into the cornice assembly, the original mild steel structure and anchorage in the cornice was severely corroded and was causing severe cracking and displacement of the terra cotta cornice assembly. This unsafe condition required complete removal and replacement of the cornice and repair/replacement of the underlying concrete and steel structural elements.

new cornice assembly. During the initial design, the team developed ideas on how to disassemble the cornice assembly while preserving several of the large bracket units since not all were in need of replacement. The team also developed re-anchorage details that allowed for several of the large bracket units to remain in place during the restoration of the cornice above. During terra cotta design and fabrication, the team modified the original cornice configuration to allow for extrusion of all the typical terra cotta cornice replacement units and to save significant cost.
